POST OAK LIFT STATION DEMOLITION

322½ N. Post Oak Lane WBS NO. R-000267-0109-3

Asbestos and Lead Survey Post Oak Lift Station FN 546 322 ½ N. Post Oak Lane Houston, Texas

WBS No. R-000267-0109-3 Task No. 12-21

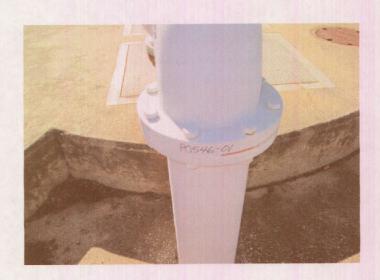
Three bulk material samples were collected of flange gaskets. No asbestos was detected in the samples collected.

Piping Flange Gasket (PO546-01) ND

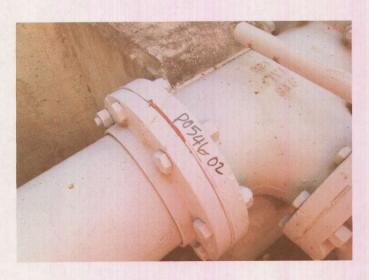
Dry Well Flange Gasket (PO546-03) ND

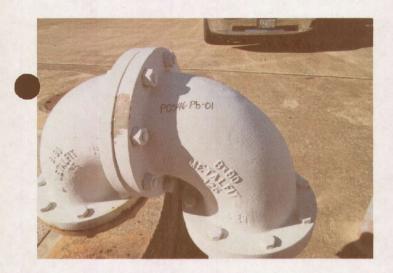
Gray paint on exterior piping (PO546-Pb-01) had a lead content of 272 mg/Kg and is not a lead based paint. The paint is in general good condition. OSHA regulations apply to workers during demolition or renovation.

Gray Piping Paint (PO546-Pb-01) 272 mg/Kg

The lift station is scheduled for demolition in the future. Recycle all metal components including those with lead containing paint. No lead abatement required.

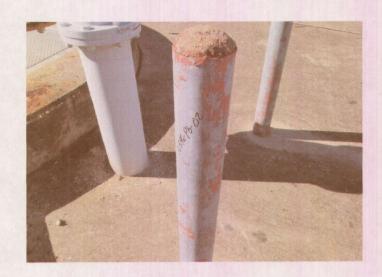
Red ballard paint (PO546-Pb-02) had a lead content of 924 mg/Kg and is a lead based paint. The paint is in poor condition. OSHA regulations apply to workers during demolition or renovation.

Red Ballard Paint (PO546-Pb-02) 924 mg/Kg

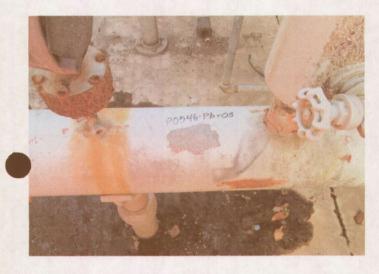
Gray paint on drywell piping (PO546-Pb-03) had a lead content of 291 mg/Kg and is not a lead based paint. The paint is in fair condition. OSHA regulations do not apply to workers during demolition or renovation.

Drywell Gray Piping Paint (PO546-Pb-03) 291 mg/Kg

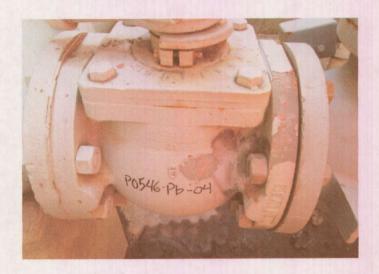
Gray paint on a dry well valve (PO546-Pb-04) had a lead content of 269 mg/Kg and is not a lead based paint. The paint is in general fair condition. OSHA regulations apply to workers during demolition or renovation.

Drywell Valve Paint (PO546-Pb-04) 269 mg/kg

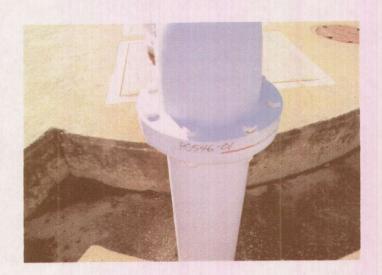
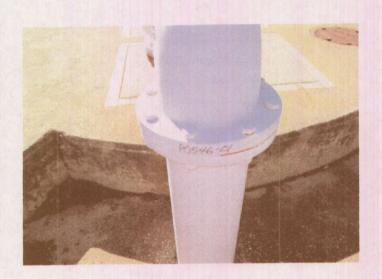
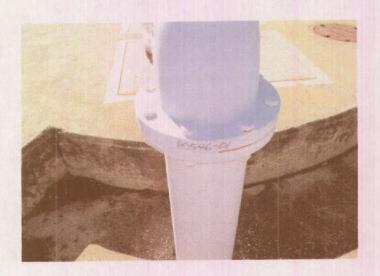
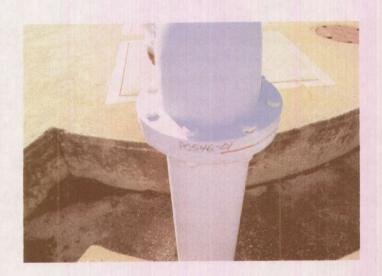
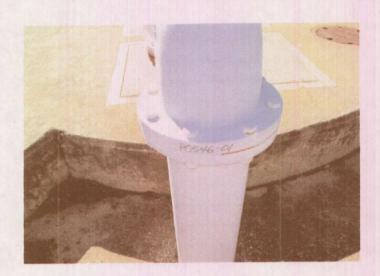
Piping Flange Gasket (PO546-01) ND

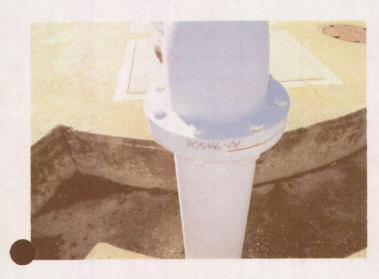
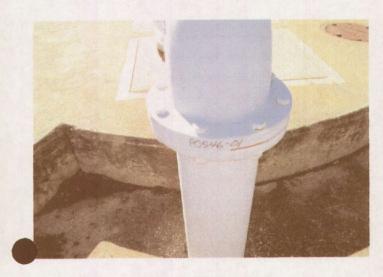
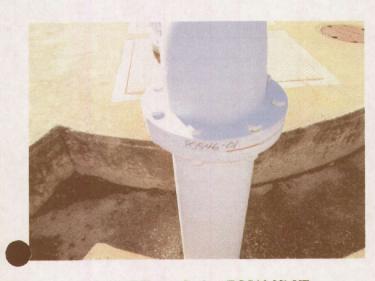
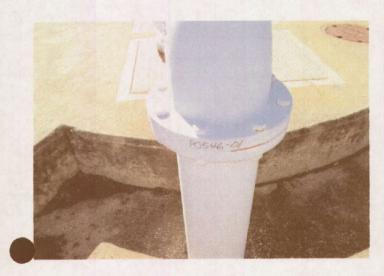
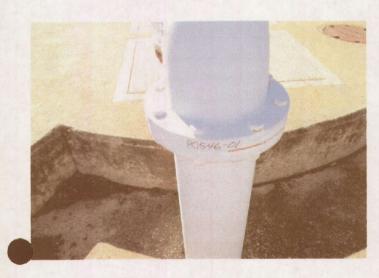
Dry Well Flange Gasket (PO546-02) ND

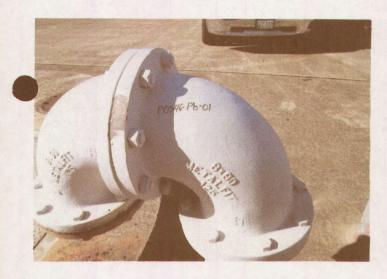
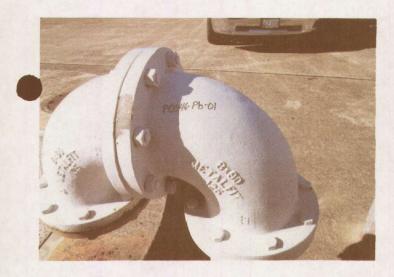
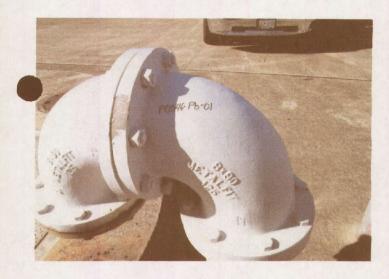
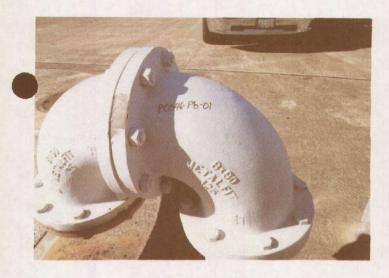
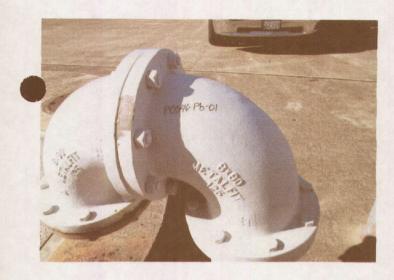
Gray Piping Paint (PO546-Pb-01) 272 mg/Kg

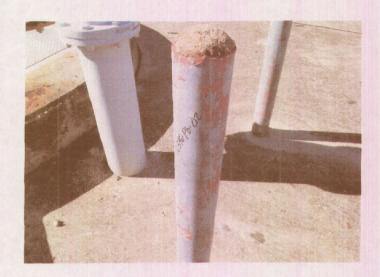
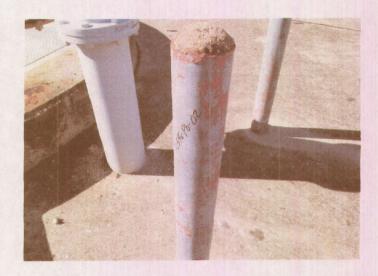
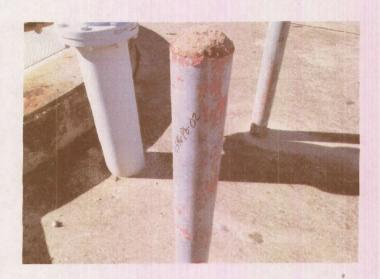
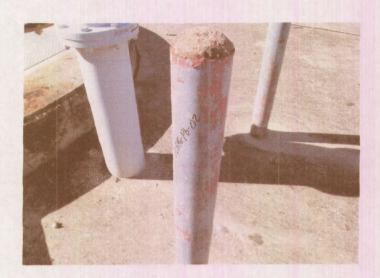
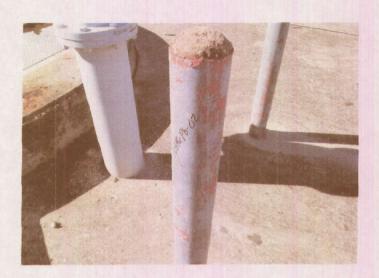
Red Ballard Paint (PO546-Pb-02) 924 mg/Kg

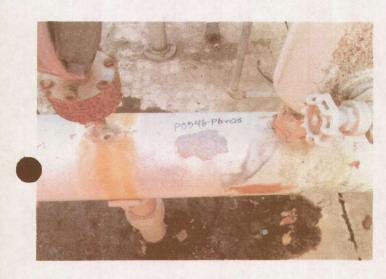
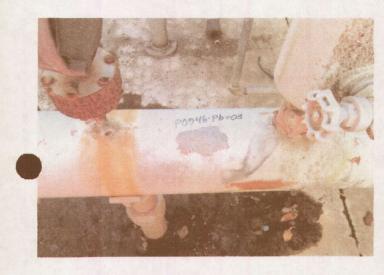
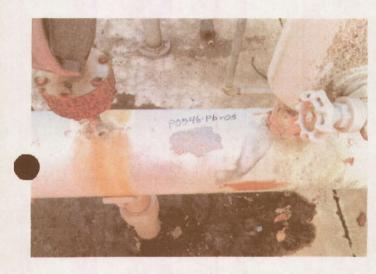
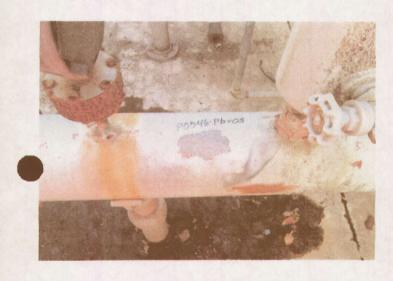
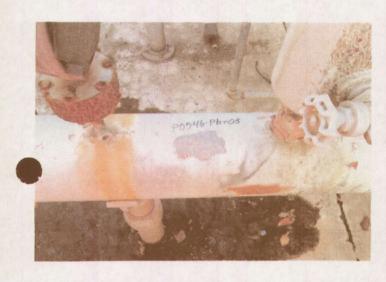
Drywell Gray Piping Paint (PO546-Pb-03) 291 mg/Kg

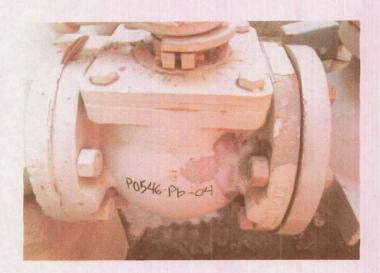
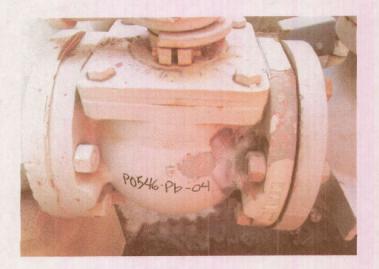
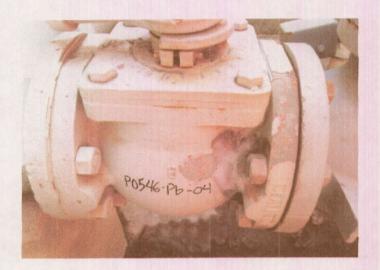
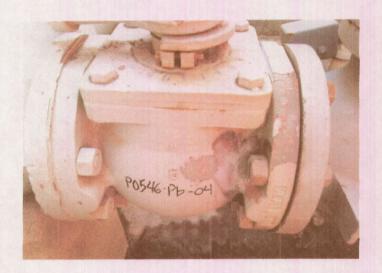
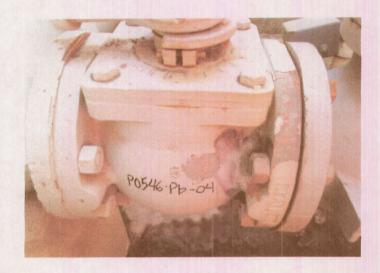
Drywell Valve Paint (PO546-Pb-04) 269 mg/kg
